The Impact of Rainfall on The Conservation of Traditional Nigerian Heritage Buildings: A Case Study of The Museum of Traditional Nigerian Architecture (MOTNA), Jos ¹

Iliya MELA and Yongkang CAO

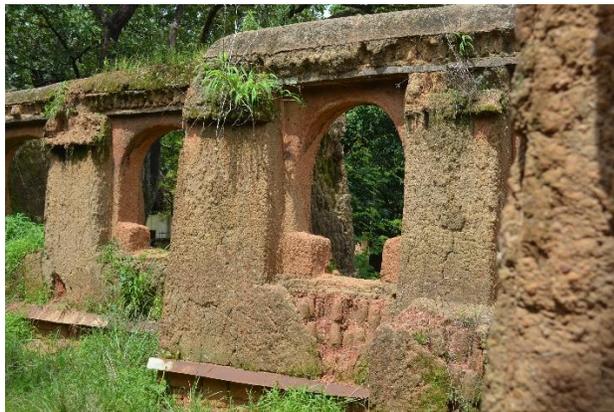
As it stands now, the Friday Mosque has largely crumbled to the ground. The effect of continuous contact with water can be seen in various elements of the building. Due to the building's flat roof and lack of overhangs, its earthen roof, walls, and foundation are constantly subjected to the elements of weather, such as rainfall and humidity. It appears that the walls have absorbed a considerable amount of rainfall and water content to the point where plants, grasses, and mold are flourishing on them. This is possible because within its walls are plants and seeds that can grow if exposed to the right conditions over a prolonged period.

Figure 3: Ruins of Zaria Friday Mosque

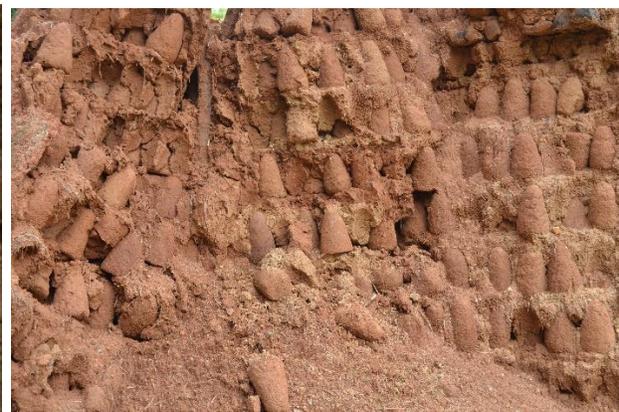
Figure 4: Oval earth bricks (Tubali)

A cross section of a tubali wall as seen in figure 4 indicates that the mud bricks weren't the most affected. Instead, it was the earth that was used to bind the tubalis together. These had a large proportion of sand in them as opposed to the tubalis, which were of a finer particle and were properly compressed. It can be concluded that rainfall had a more significant effect on the mortar than on the brick.

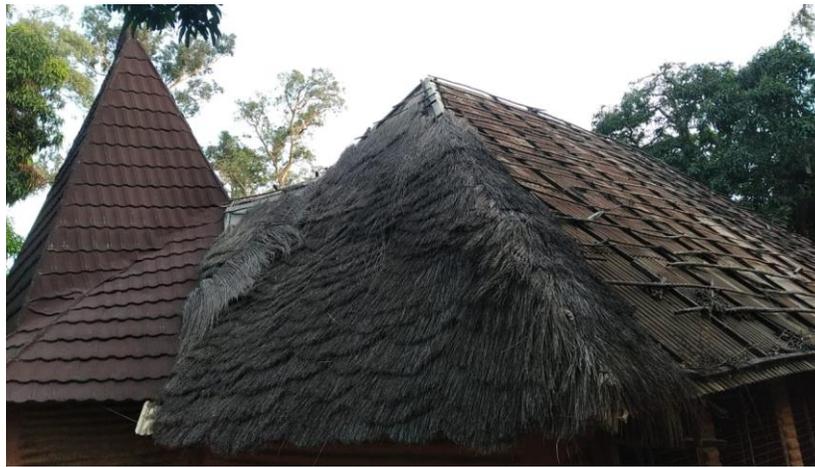
Roof: In this case, the roof was the most impacted by the effect of rainfall. Initially, the roof was made of wooden slates, as was the case in a typical Benin palace. Over time, the effect of rainfall, which led to moisture exposure, began to deteriorate the roof. Upon the deterioration of the wooden slates, they were replaced with yet another local material, thatch. However, inconsistency in routine roof replacement led to the imminent decay of the straw due to prolonged exposure to rainfall. At present, the roof of the building looks nothing like its original design. This is because the local roofing material has been replaced with a combination of corrugated zinc and aluminum roofing sheets.

Figure 5: deteriorated thatch and bamboo poles sitting on aluminum and zinc corrugated sheets

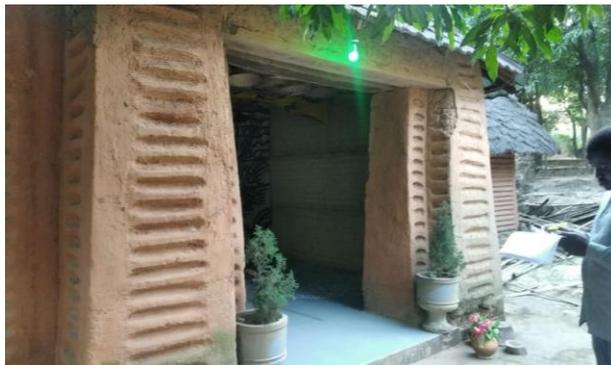
Figure 6: Entrance to Benin palace

Walls: The lower part of the walls has been impacted by rainfall due to an inadequate roof overhang, which was unable to keep the wall dry in wet weather. Until a drainage system was made around the perimeter of the building as part of a conservation intervention, it was constantly affected by erosion and the absorption of surface runoff from its foundation upwards. This is evident from the gradual disintegration of the wall rendering and the growth of mold at the base of the wall.

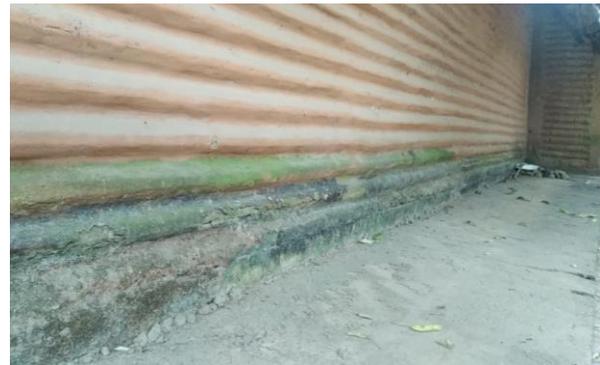
Figure 7: Mold on the base of exterior walls

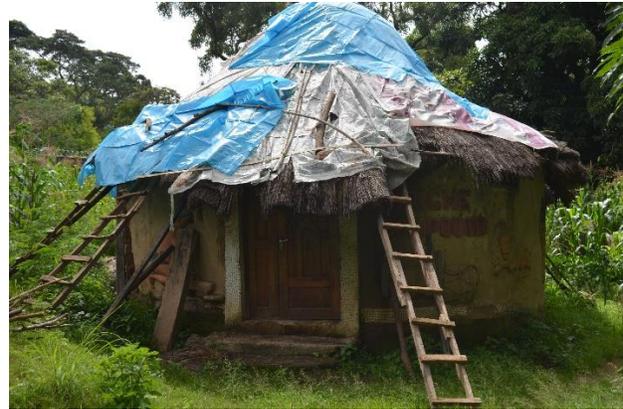
The photos below show the state of the buildings in the compound as of December 2020. At that point, all the roofs in the compound were leaking. Polythene sheets had to be introduced as a conservative measure to prevent any further damage to the thatch. The renderings on the wall had multiple cracks, and the effects of water and wind erosion can be seen on it. Part of the foundation was already exposed because of erosion.

Figure 9: Irigwe hut conservation in 2020

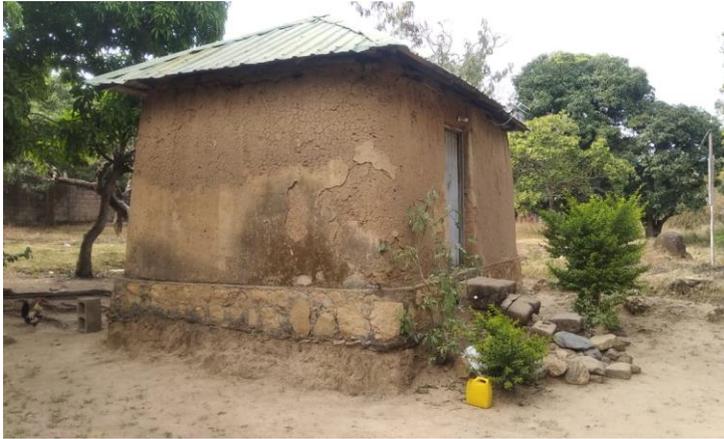
As of today, only one hut remains in the compound and its walls are in a dilapidated state. A significant portion of the clay mortar has been washed off while the other part is filled with cracks. The traditional bamboo and thatch roof has been replaced with corrugated metal roofing sheets and traditional modern timber. The foundation is fully exposed, so much so that the foundation now sits at a height of about 450mm above present ground level.

Figure 10: sole standing Irigwe hut in 2022

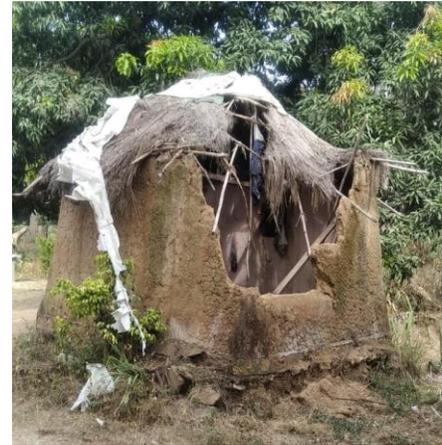
Figure 11: Dilapidated hut 2022

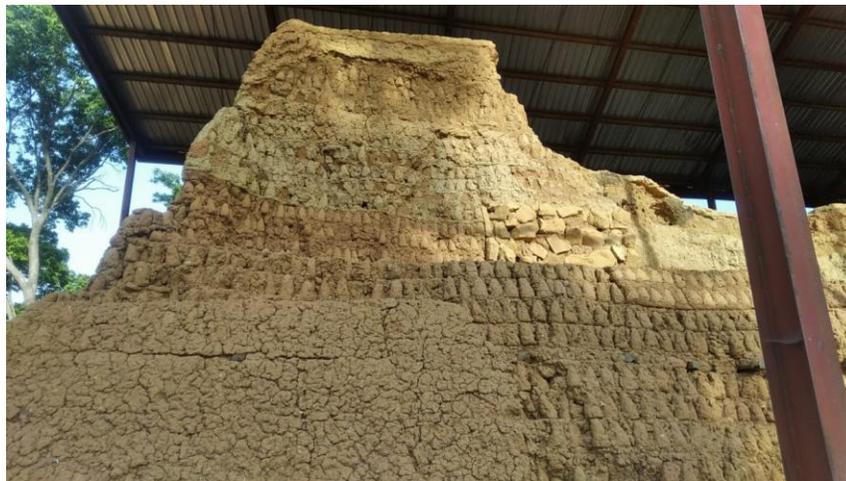
The wall in Kano, like the mosque in Zaria, is originally from a warm semi-arid climate (BSh). It is a replica of the great walls of Kano, built in the tenth century. It was constructed using the tubali system of construction. For structural support, azara (palm wood) was used. Like the Zaria Friday Mosque, the Great Wall of Kano faces a similar challenge, with rain constantly washing off its mud protective layer and subsequently the tubalis. Its lack of covering and waterproof quality makes it quite susceptible to rainfall. As a result, a significant part of it has been eroded by rainfall and wind. A conservative intervention in the form of a canopy was carried out to preserve its remains but its deterioration continues.

Figure 12: section of great wall of Kano with stacks of tubali under a canopy as conservation intervention

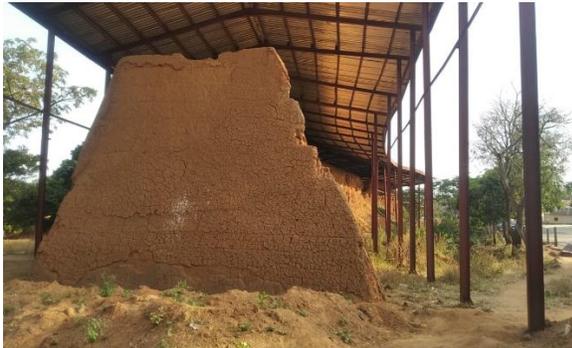
Figure 13: side view of Kano wall

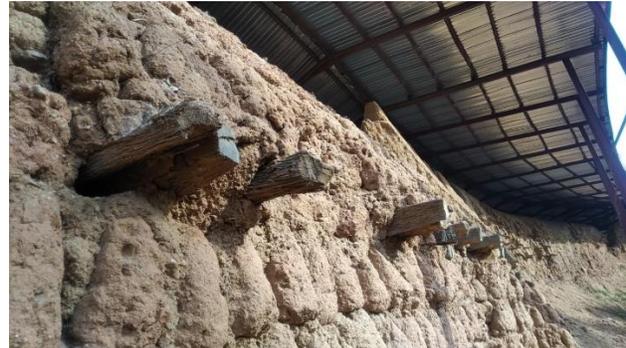
Figure 14: Exposed palm wood on earth wall
